Docket No. 217 – Development and Management Plan Inspection

Northeast Utilities Service Company Certificate of Environmental Compatibility and Public Need for the construction of a 345-kV electric transmission line and reconstruction of an existing 115-kV electric transmission line between Connecticut Light and Power Company's Plumtree Substation in Bethel, through the towns of Redding, Weston, and Wilton, and to the Norwalk Substation in Norwalk, Connecticut.

Date: June 20, 2006

Location: Transition Stations: Hoyts Hill, Archers Lane, Norwalk Junction

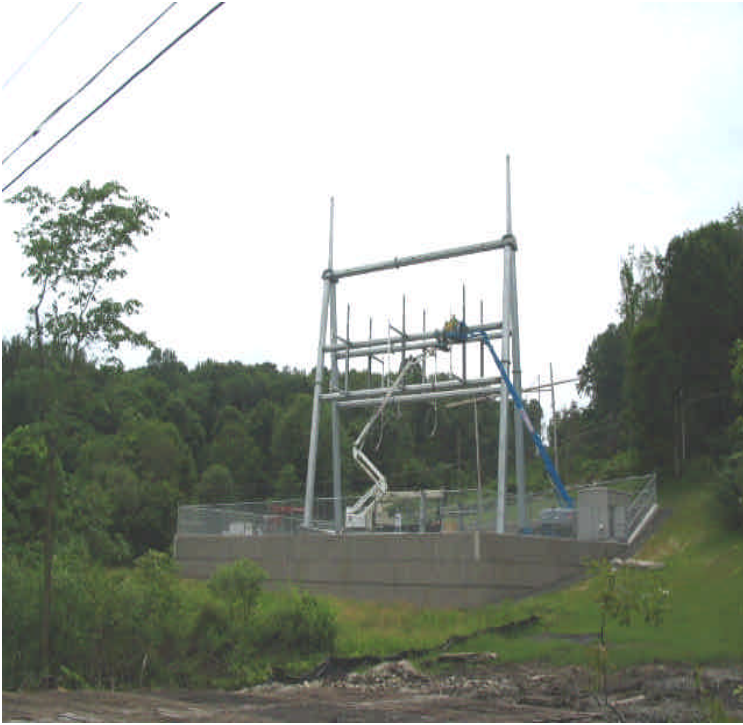
Hoyts Hill Transition Station: Photo on the left shows an overview of the pad where some structure work was occurring. Photo on the right shows where an old filter bag remains from previous dewatering. This should be removed and disposed of when feasible. 6/20/06

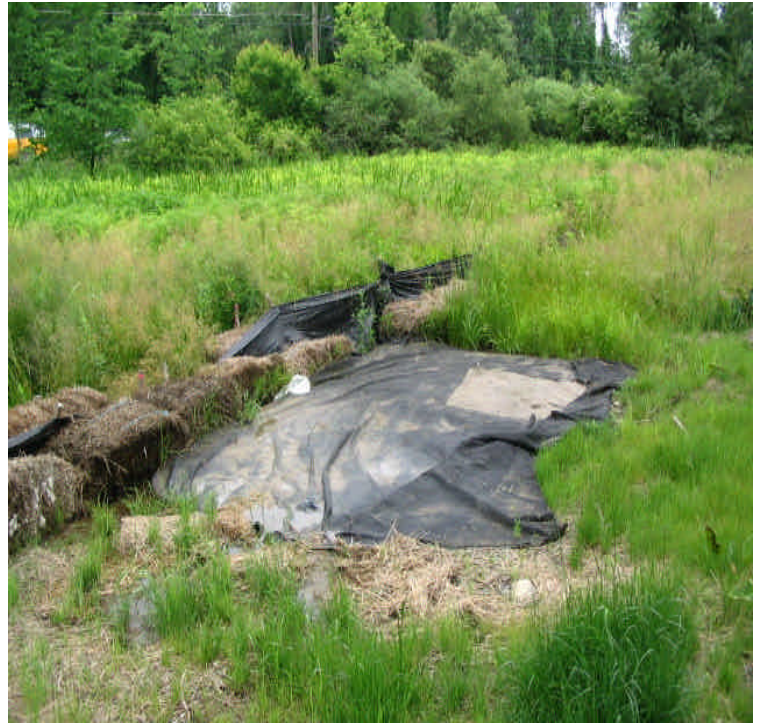
Dewatering Hoyts Hill Archers Lane Norwalk Junction	-Dewatering was no longer noted here. The old filter bag remains by the silt fence. 6/14-6/20/06 - Active dewatering was not noted. 6/20/06 -Active dewatering was not noted to the swale for but haybales are in place. Some accumulated silt will be removed by	-Remove the old filter bag from site when feasible. 6/14-6/20/06. - The silt fence appeared to be filtering the water well. None at this time. 5/25-6/20/06. -Maintain controls as needed whenever dewatering is occurring and prior to rain events. 5/25-6/20/06.	-Needs attention when feasible -N/A -Some sediment accumulation will be removed

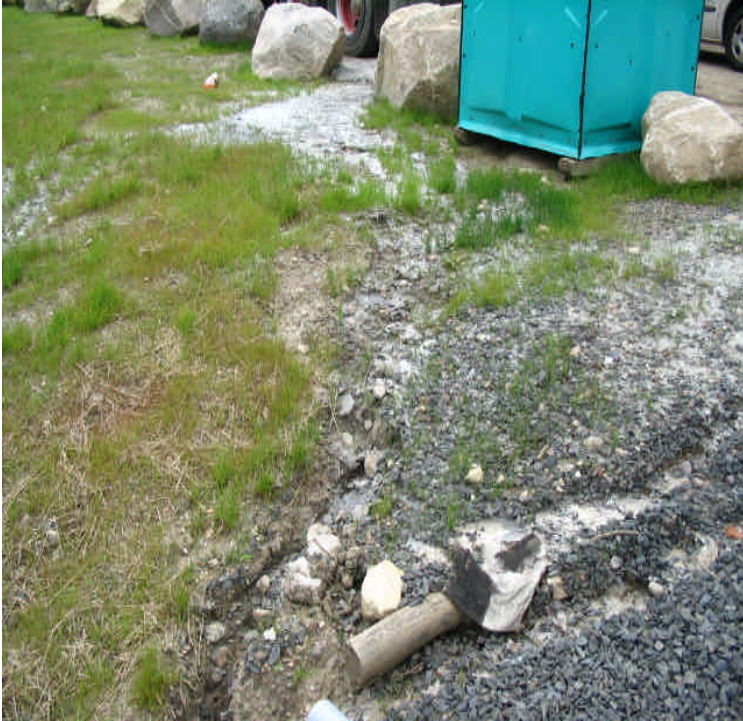
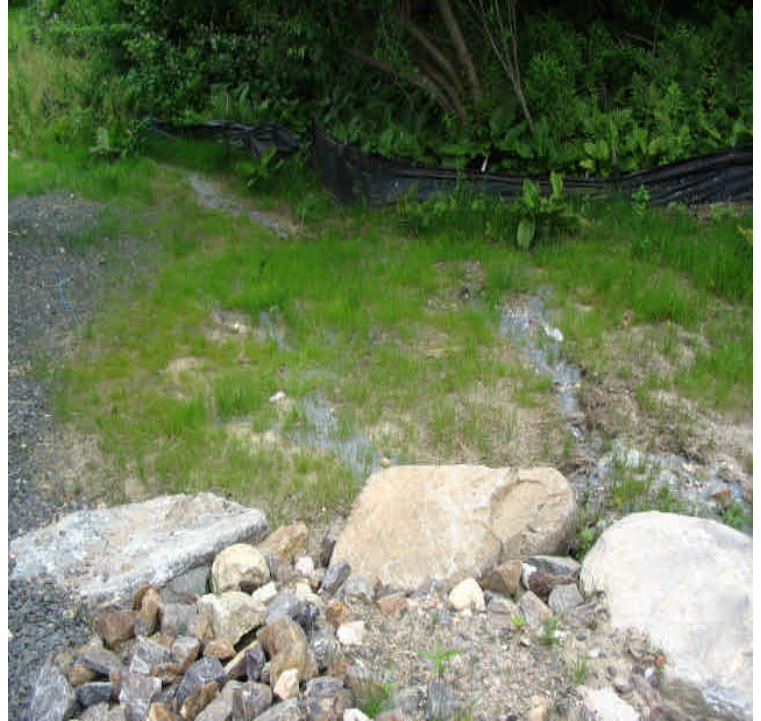
- A concrete washout was also noted at the top of slope. 6/14-6/20/06	-It is unclear which section of the project is responsible. 6/14-6/20/06	- Needs attention

Areas of Inspection	Observation	Recommended Action	Corrected Actions
Erosion and Sediment Controls continued	<ul style="list-style-type: none"> -The gullies in the southern slope are worsening and re-forming even with the recent repairs. 5/17-6/20/06. - Water running down the driveway area is not reaching the catch basin and is channeling down the slope. 6/14-6/20/06 - A concrete truck had washed out at the top of slope and washout water run down the outlet pad to the edge of wetlands. 6/14-6/20/06 - Archers Lane: Silt fence along the access road at the 1st wetland was holding back significant amounts of pooled run-off. 6/14-6/20/06 	<ul style="list-style-type: none"> -The area will need to be repaired and possible placed with erosion control mats or the pad should be extended. 6/14-6/20/06. - Consider reshaping the area so water runs to the appropriate area. 6/14-6/20/06 - This is now within the stones of the pad and should be cleaned out, as well as off the slope. Concrete drivers should all be reminded about this . 6/14-6/20/06 -Continue to monitor the fence integrity carefully and repair whenever necessary. 6/14-6/20/06 	<ul style="list-style-type: none"> - Needs attention -Needs attention - It is unclear which section of the project is responsible for cleanup but it needs attention. -N/A at this time

Both photos show where the concrete washout had run down through the existing gullies, into the outlet pad and eventually to the edge of the wetlands. This should be cleaned up and the gullies restored again. 6/20/06.

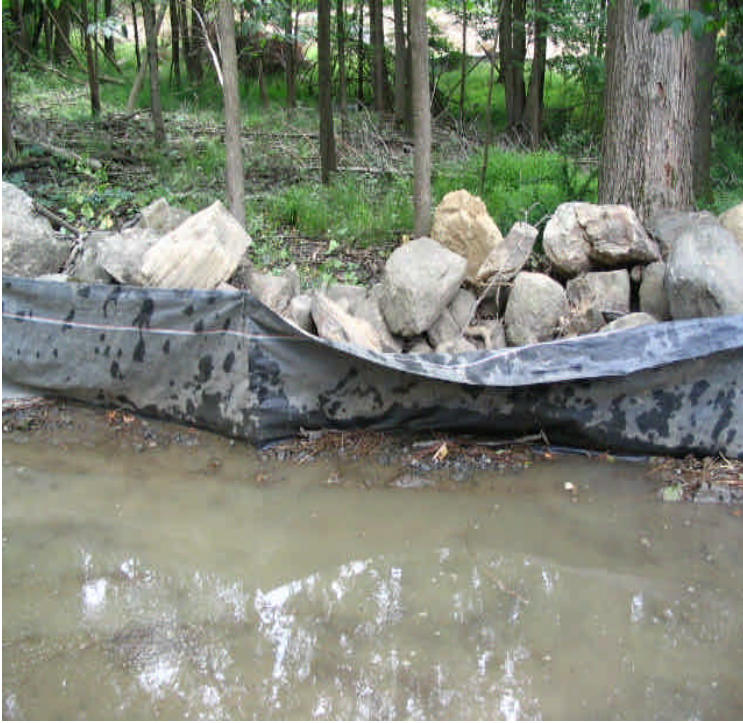
Archers Lane: Photo on the left shows the repaired silt fence at the Diamond Hill Rd entrance. A few haybales here will provide additional control but the fence is currently filtering the run-off. Photo on the right shows where silt fence was repaired near the top of slope. 6/20/06.

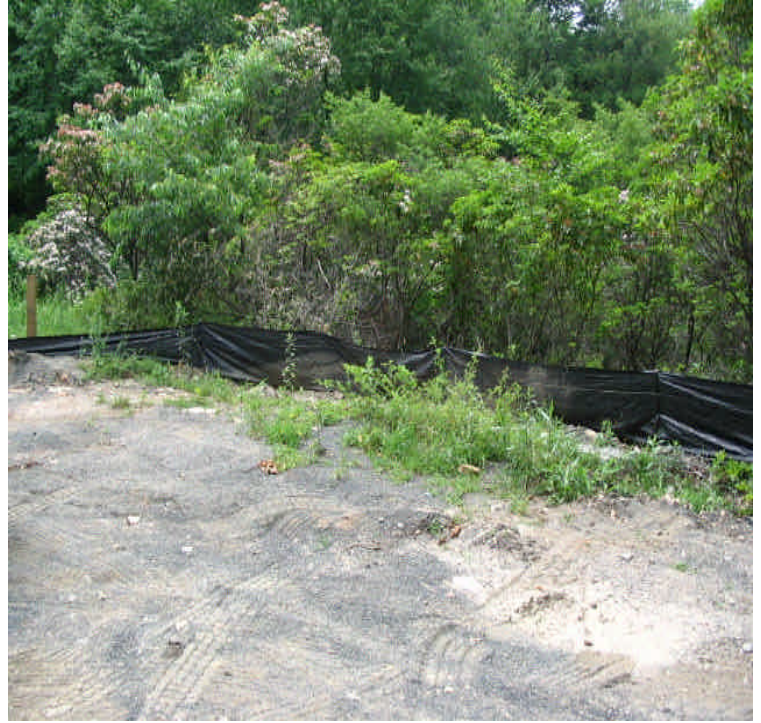
Areas of Inspection	Observation	Recommended Action	Corrected Actions
	<p>base of the access road near the stonewall was filtering pooled run-off. 6/20/06</p> <p>- Silt fence at the top of slope where process had been stored previously was repaired. 6/20/06</p>	<p>additional control if feasible. 6/20/06</p> <p>-None at this time. 6/20/06</p>	<p>feasible</p> <p>- Silt fence was repaired</p>
Erosion and Sediment Controls continued	<p>- Norwalk Junction: Perimeter silt fence and haybales remain in good shape along the river. 5/17-6/20/06.</p> <p>- The swale slopes remain in good shape and there is improved grass coverage. 6/20/06.</p> <p>-The wetland area outside the silt fence adjacent to the river contains accumulated sediment, despite the haybales in place at the culvert. 6/7-6/20/06</p> <p>-Some sediment accumulation was present in the swale due to adjacent disturbed areas and dewatering. 6/7-6/20/06</p>	<p>- None at this time. Continue to monitor controls. 5/17-6/20/06.</p> <p>-None at this time. Continue to monitor. Maintain when needed 6/20/06.</p> <p>- The silt is contained and does not reach the river. Wetland vegetation was also noted growing here, but silt has built up at the stone outlet and should be removed by hand. 6/1-6/20/06</p> <p>Continue to improve water quality to the swale. Maintain/ remove sediment when feasible. 6/1-6/20/06.</p>	<p>-N/A</p> <p>- N/A</p> <p>- Needs attention</p> <p>- Needs attention if feasible (345kV contractors will be removing some)</p>

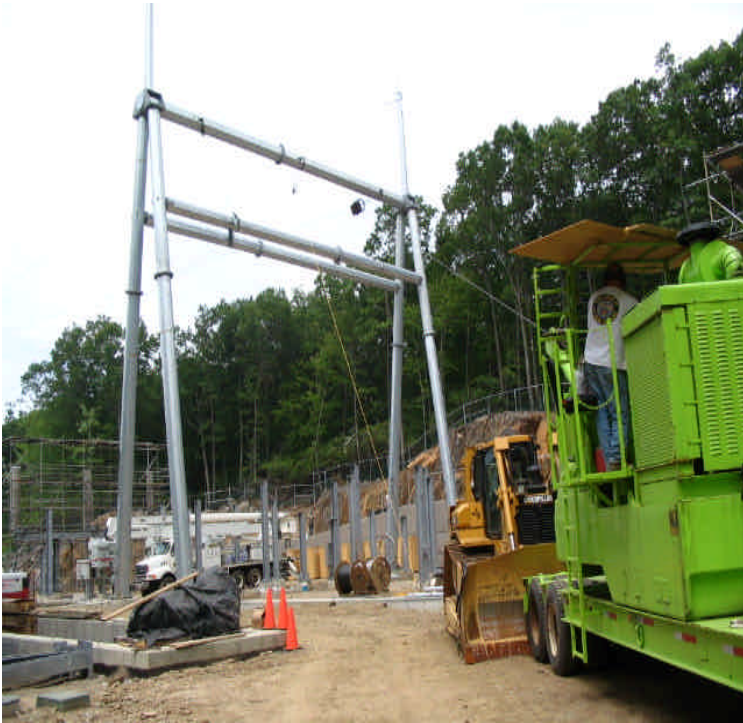
Photo on the left shows ongoing work on the station pad. Crews were pulling wire at the time. Photo on the right shows the restored silt fence, retaining and filtering run-off. It is unclear if efforts were made to remove the accumulated sediment. Some remains in the wetland. 6/20/06.

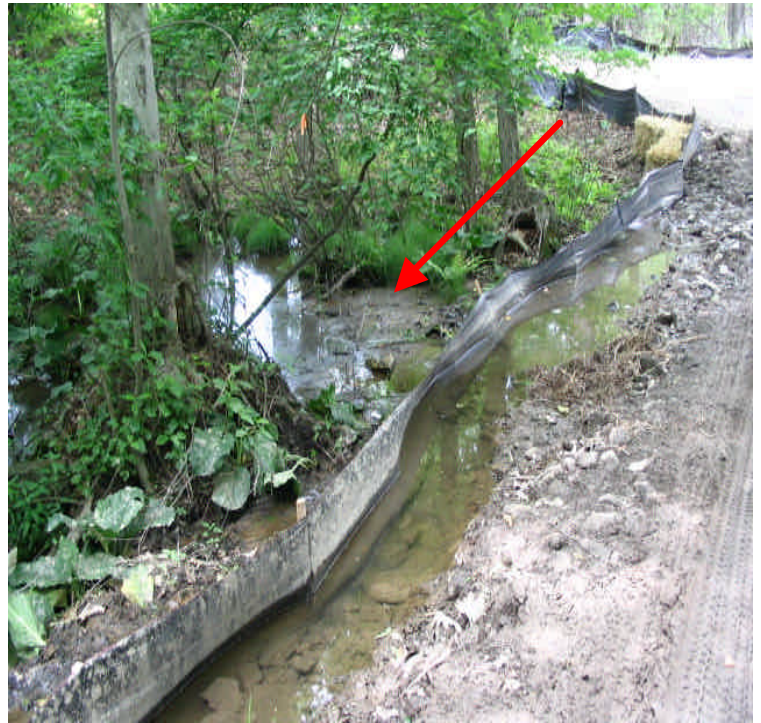
- The repaired silt fence along the access road continues to hold back a significant amount of turbid run-off from the wetland. 6/14-6/20/06	- Continue to monitor and repair when necessary. 6/20/06	- N/A
	-Slopes remain disturbed along the access road where 345kV trenching	-The area should be restored after vault access and work here is	- Needs attention when work is complete

<ul style="list-style-type: none"> -Efforts will be made during good weather to remove the accumulated sediment which remains in this wetland. 4/26-6/20/06. - A spot along the silt fence on the access drive in the ROW needs repair as stone washed over and built up here adjacent to the 2nd wetland crossing. 5/17-6/20/06 -Restoration efforts will be necessary along the disturbed slopes of the access road from Diamond Hill. 4/26-6/20/06 - The silt fence at the 	<ul style="list-style-type: none"> -Any easily accessible deposits of sediment need to be removed. It's unclear whether this had occurred. 6/14-6/20/06 - Repair fence and pull back stone as needed. Another spot is filling up but not overtopped. 5/17-6/20/06 - AL contractors will likely need to perform restoration when work is complete here. 5/4-6/20/06 - Install haybales here for 	<ul style="list-style-type: none"> -May still need attention. - Needs attention (but may be overhead jurisdiction) - N/A at this time. - Needs attention if

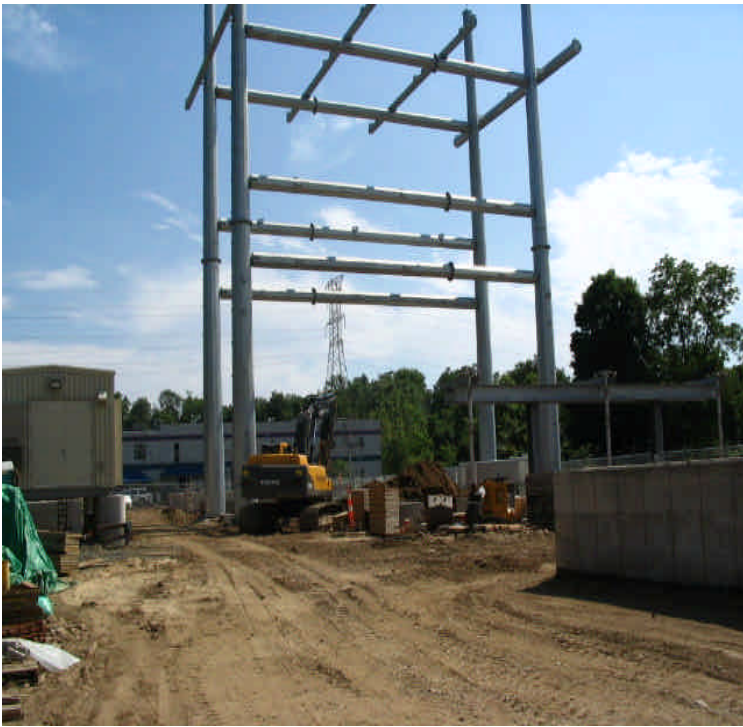
Norwalk Junction: Photo on the left shows a view of the station. Some buildings have been placed permanently on posts in response to flooding events. Photo on the right shows a view of the swale and the increasing vegetation. 6/20/06.

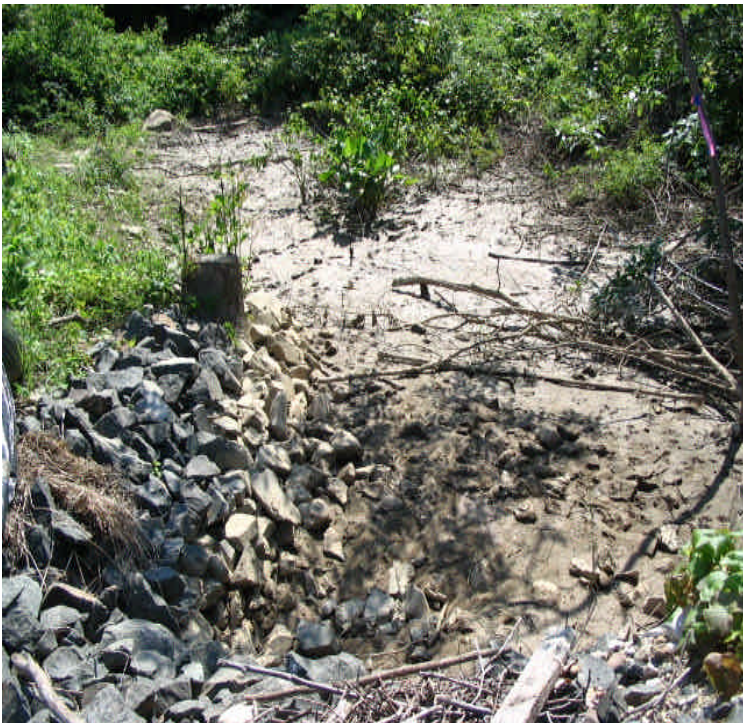
Areas of Inspection	Observation	Recommended Action	Corrected Actions
	in good shape. 6/20/06. - Norwalk Junction: The outlet of the drainage swale is at the headwall of the wetland area. Wetland vegetation was growing but silt has accumulated 6/14-6/20/06	- Reduce turbidity by controlling its source-disturbed surfaces and dewatering on site. The area does not seem affected but deeper sediment buildup at the outlet should be removed. 5/25-6/14/06.	
State species of concern, threatened and endangered species	- No species of concern are located in these areas of construction.	- N/A	-N/A
Vegetative clearing limits (including trees to save or danger trees noted)	- Hoyts Hill: During the rain, it was apparent that the southern slope gullies were re-forming. 6/7-6/14/06. - Mats are placed for access at the wetland off Rt 58. 6/20/06 - Archers Lane: no additional clearing was noted here. 6/14/06. - Norwalk Junction: - Vegetative growth continued in the area between the silt fence and the river. 6/14/06.	- See erosion control section. 6/7-6/14/06. - Continue to monitor and do not access the wetland without mats. 6/20/06 -None at this time. 6/14/06. - Continue to monitor and restore perimeter surfaces. 6/1-6/14/06.	-Needs attention -N/A -N/A -N/A

Photo on the left shows the wetland area at the end of the swale where sediment accumulation is noticeable. Sediment should be carefully removed by hand from this area. Photo on the right shows the area along the river with silt fence remaining in place. 6/20/06.
